# Workmanship Standards *for* Licensed Contractors

JUNE 2009

**STATE OF ARIZONA  
REGISTRAR OF CONTRACTORS**

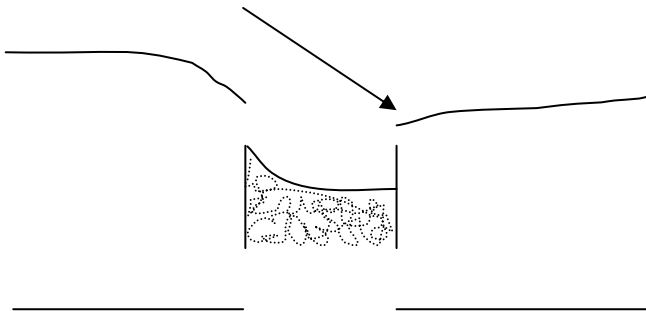
- 8. PD Missing or irregular grout.  
AT None. Grout should be flush to the top edge of the adjacent tile.  
CR Contractor should make necessary repairs.

Exposed vertical face of tile is unacceptable

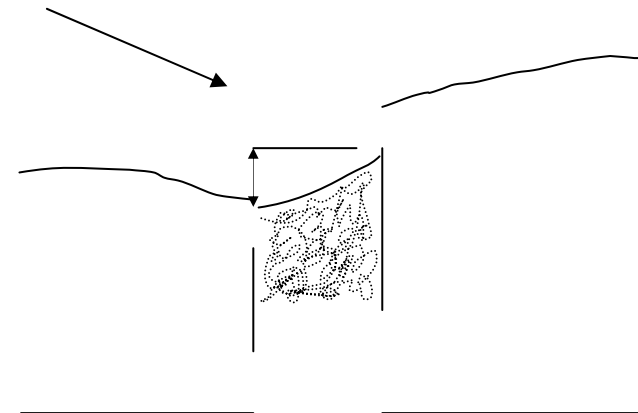
5. PD Uneven tiles.  
AT Lippage of more than 3/16" is unacceptable. Inherent characteristics of the tile dictate the method of installation of the tile. All unusual characteristics of the tile should be explained to the owner or the owner's agent prior to installation.  
CR Contractor should make necessary repairs.

Lippage of more than 3/16" is unacceptable
